Scotts Millpond Dam (Inventory Number VA 05706 Rappahannock River Basin.
Essex County, Commonwealth of Virginia.
Phase I Inspection Report.

4. TITLE (and Subtitle) Phase I Inspection Report National Dam Safety Program Scotts Millpond Dam Essex County, VA		5. TYPE OF REPORT & PERIOD COVERED Final

Name of Dam: Scotts Millpond Dam
State: Commonwealth of Virginia
County: Essex
USGS 7.5 Minute Quadrangle: Mount Landing, Virginia
Stream: Hoskins Creek
Date of Inspection: 14 November 1980

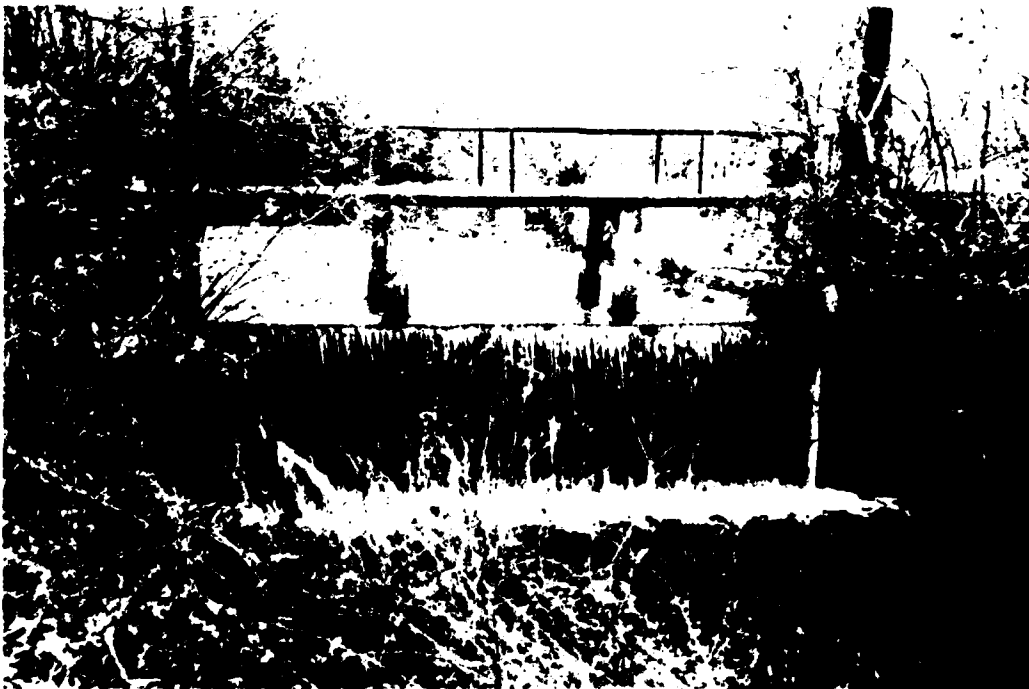
PHOTO 2. Principal Spillway Outlet

VISUAL EXAMINATION OF	OBSERVATIONS	REMARKS OR RECOMMENDATIONS
CRACKING AND SPALLING OF CONCRETE SURFACES IN OUTLET CONDUIT	The principal spillway consists of a rectangular concrete open channel, with concrete and brick sides, excavated into the natural knoll between the left and right embankments. The concrete and brick are in good condition with no cracks or spalling.	
INTAKE STRUCTURE	The inlet to the spillway is a low flow concrete weir with a vertical upstream face at the edge of the reservoir and a slight curve on the downstream face.	The weir is completely submerged by moderate and high flows.
OUTLET STRUCTURE	The spillway outlet is a concrete channel with concrete and brick sides. There is a footbridge over the channel with four concrete piers in the channel. The concrete and brick are in good condition, but there is some minor debris along the channel sides.	The debris should be removed from the channel.

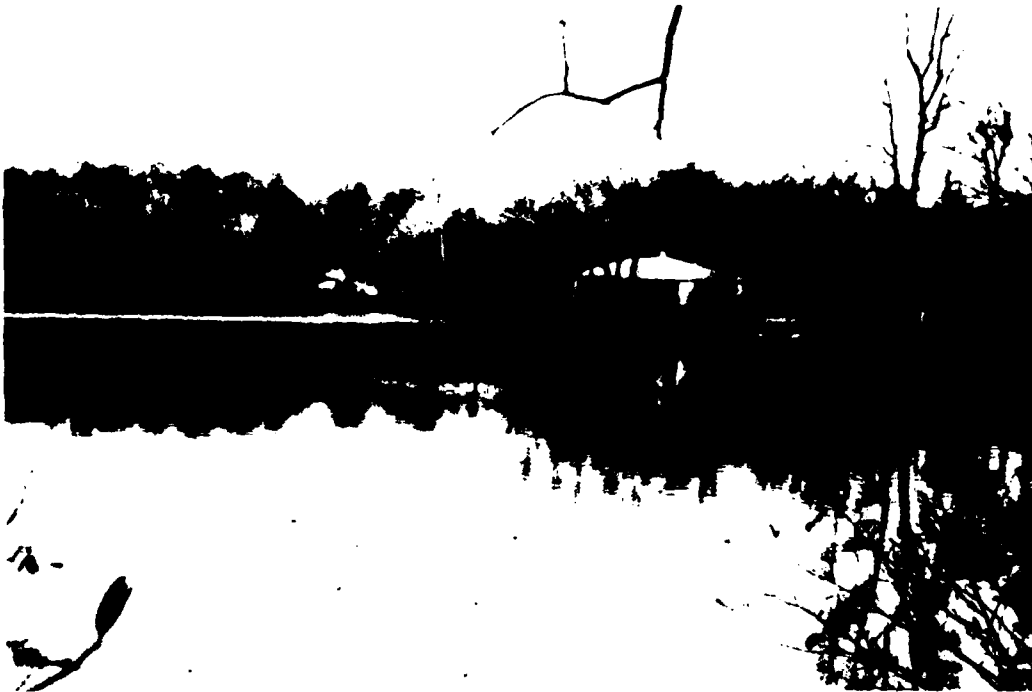
**PHOTO 5. Natural Knoll, Left Embankment, Principal Spillway to
Right of House**
